# CLEANING AND CHEMICAL TREATMENT OF AIRCRAFT SURFACES TO PROVIDE OPTIMUM COATING PROPERTIES

Final Summary Report
(23 October 1967 to 23 October 1970)

Naval Air Systems Command Department of the Navy

Lockheed-Georgia Company
A Division of Lockheed Aircraft Corporation
Marietta, Georgia

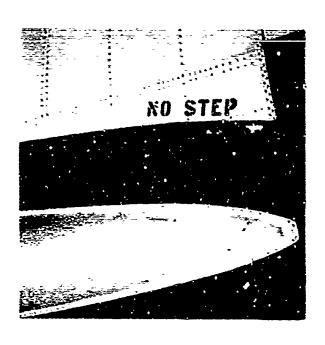
F!GURE 64 TEST AREA NO, 10 (DARK SECTION WAS NOT REPAINTED AND IS NOT A PORTION OF THE TEST AREA)
